Manhole Inspection Summary

Manhole # S37KK_034MH

Insp Date: **3/19/07 10:59 AM**

Location Address: **1812 GREENMOUNT AVE**

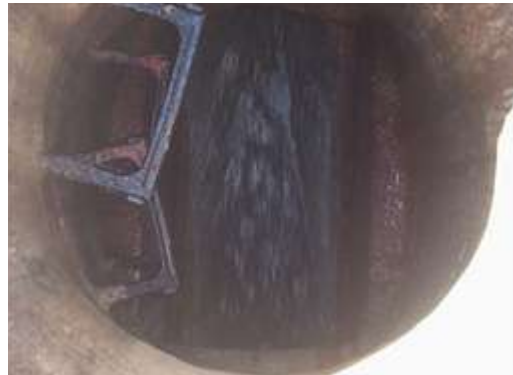
Top View

Infiltration: ☐ None ☒ **Joint** ☐ Cracks ☐ Mortar ☐ Roots ☒ **Wall**

Infiltration: ☐ None ☐ Joint ☐ Cracks ☐ Mortar ☐ Roots ☒ **Wall**

☐ Parged ☒ **Debris** (not Condition related)

Corbel and Barrel infiltration. Bench debris.

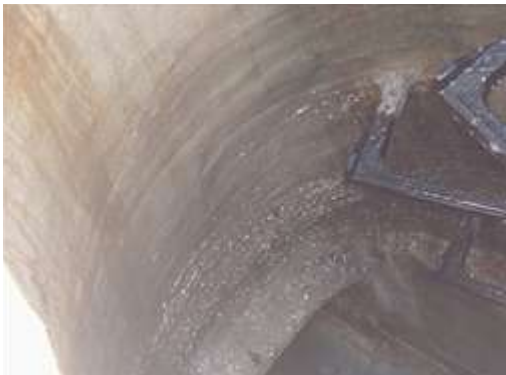
Defect

☒ **Evidence Of Surcharge** Depth: **4** (ft.) ☐ Active Surcharge Present

Barrel infiltration. Evidence of surcharge.

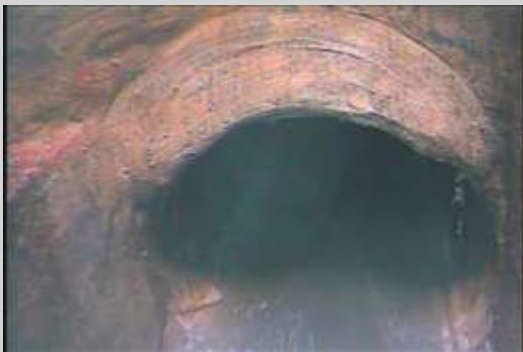
27 in. Circular Gravity Sewer Pipe Out @ 12 O'Clock

Infiltration: **None** Pipe Seal Cond: **Unknown**

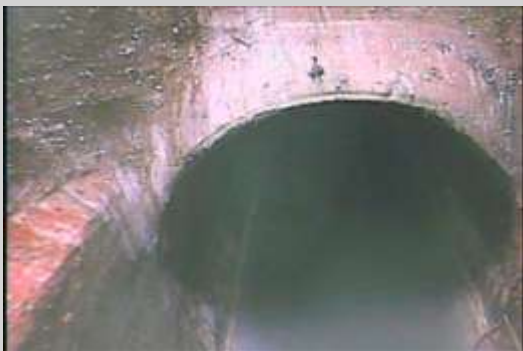
27 in. Circular Gravity Sewer Pipe In @ 6 O'Clock

Infiltration: **None** Pipe Seal Cond: **Unknown**
